Manhole Inspection Summary

Manhole # S23KK1008MH

Insp Date: **7/15/07 12:05 AM**

Location Address: **COLD SPRING LN**

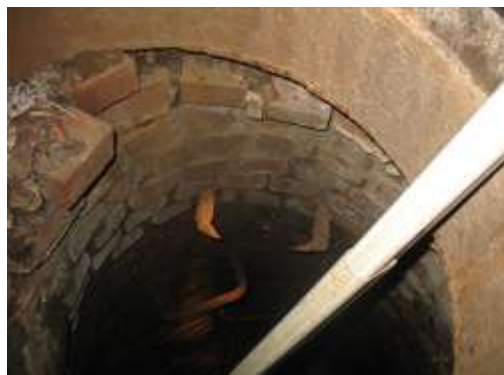
Location View

PIC OF BROKEN STEP AND
LOOSE/MISSING BRICKS

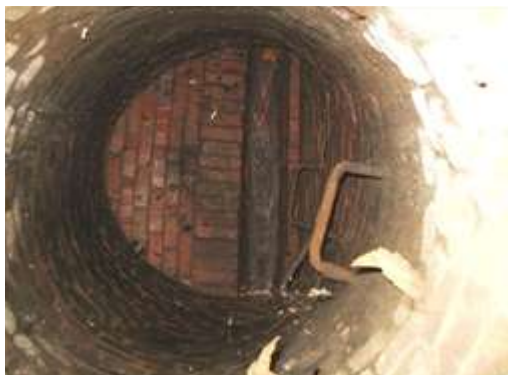
Top View

Steps Count: **5** Missing: **1** ☒ **Corroded**

Corroded and missing steps.

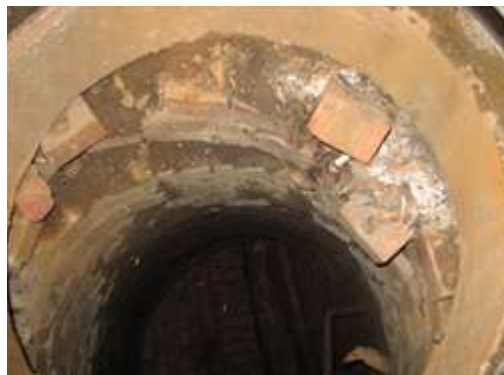
Defect

Frame leaks. Frame offset. Adjustment
deterioration, loose brick and infiltration.
Corbel and Barrel infiltration.

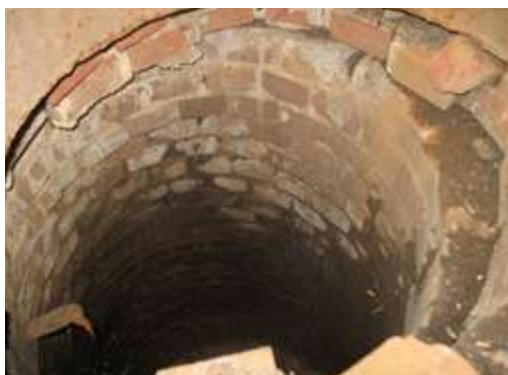
Defect

Frame leaks. Adjustment deterioration,
loose brick and infiltration. Corbel and
Barrel infiltration.

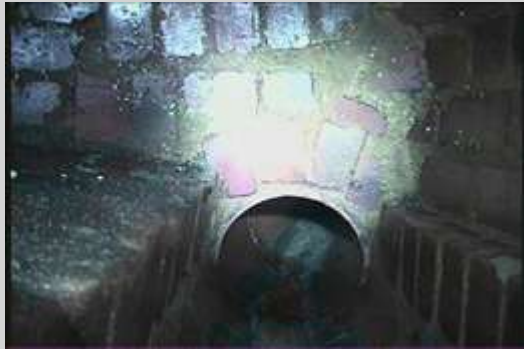
8 in. Circular Gravity Sewer Pipe Out @ 12 O'Clock

Infiltration: **Evidence** Pipe Seal Cond: **Unknown**

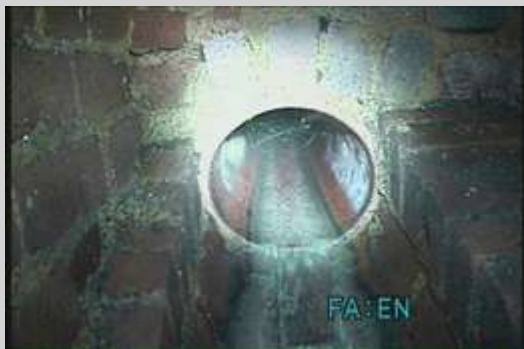
8 in. Circular Gravity Sewer Pipe In @ 6 O'Clock

Deposits: ☐ None ☐ Mud ☐ Sludge ☐ Debris ☒ Grease

Silt Depth: **0** (in.) Deposits Extent: **Light**
